# ROHM & HAAS COMPANY

REDSTONE ARSENAL RESEARCH DIVISION

Report No. S-16

Report of Fatal Explosion - March 28, 1958

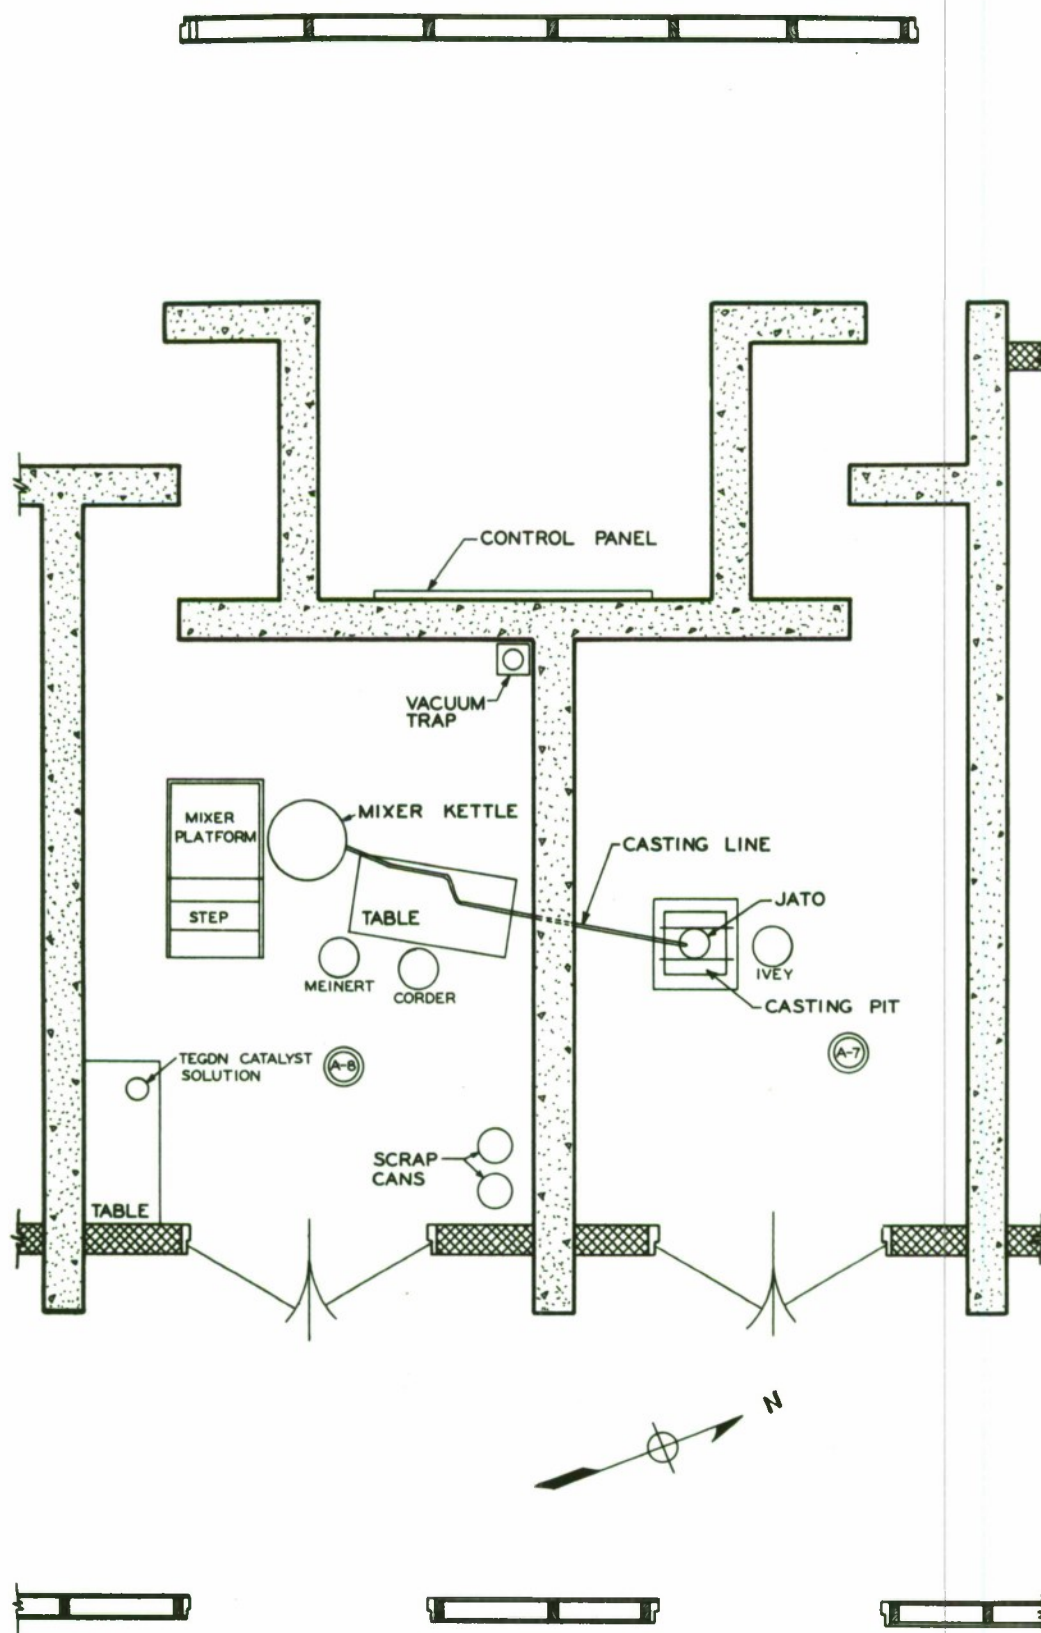
Fig. 2 Floor plan of bays A-7 and A-8 in Bldg. 7595.

Corder had just entered the bay to help refill the catalyst burette and both Meinert and Corder were standing in front of the catalyst burette (Fig. 2). Meinert was apparently standing to the south and was probably turned partially toward Corder who was probably facing the table almost directly. They stood within two feet of the in-line mixer, though their attention was on the burette in front of the mixer.

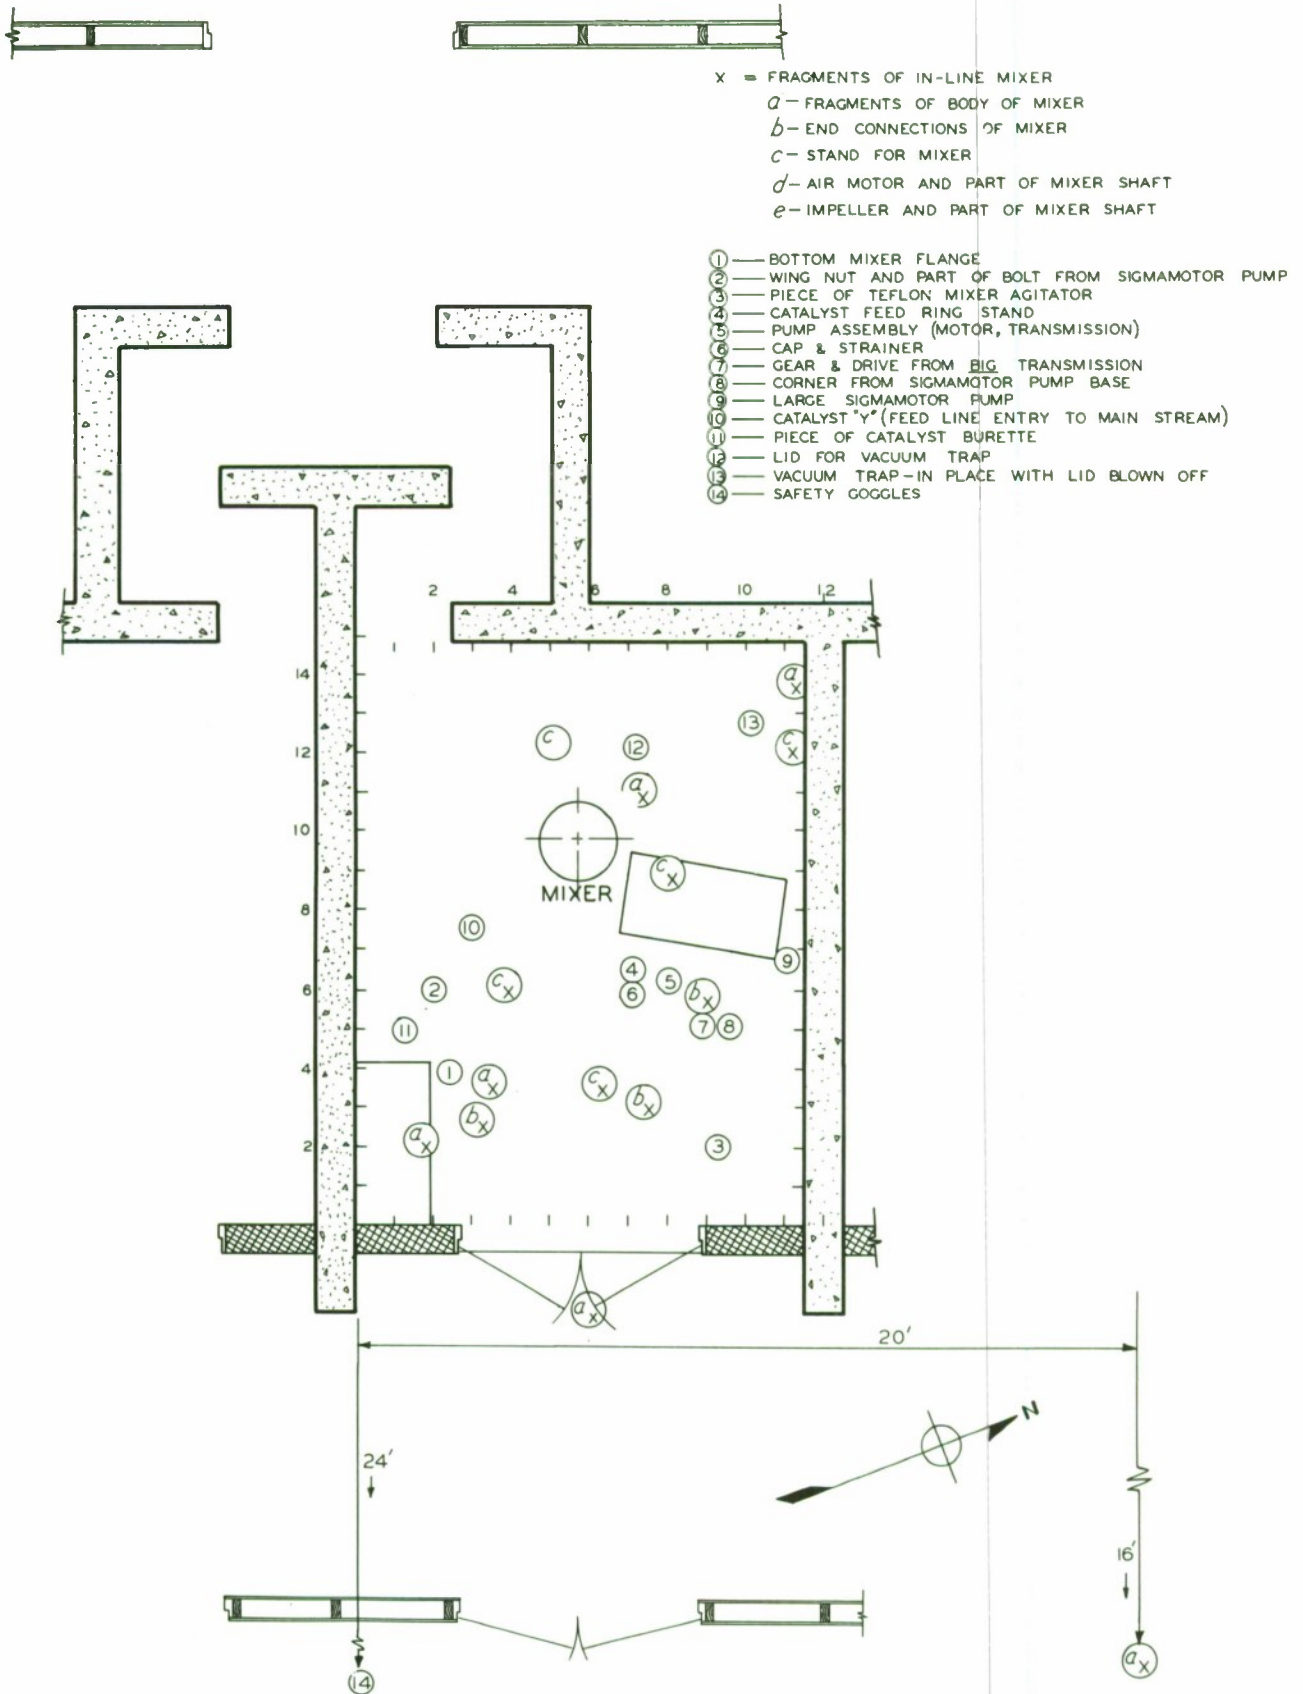
Fig. 8 Floor plan of bay A-8 showing location of fragments

The explosion apparently started in the in-line mixer and blew this into five large pieces (Figs. 8 & 9), one of them consisting of the upstream mixer head and the other four almost symmetrical longitudinal fragments of the downstream mixer body. A loud report and bright flash with a spray of burning propellant occurred almost simultaneously. Flying fragments of this mixer and neighboring parts (Fig. 10), such as a hose clamp apparently from one end of the mixer, caused fatal wounds to Corder, while Meinert was cut by a fragment but suffered mainly from flash burns from the spraying propellant.

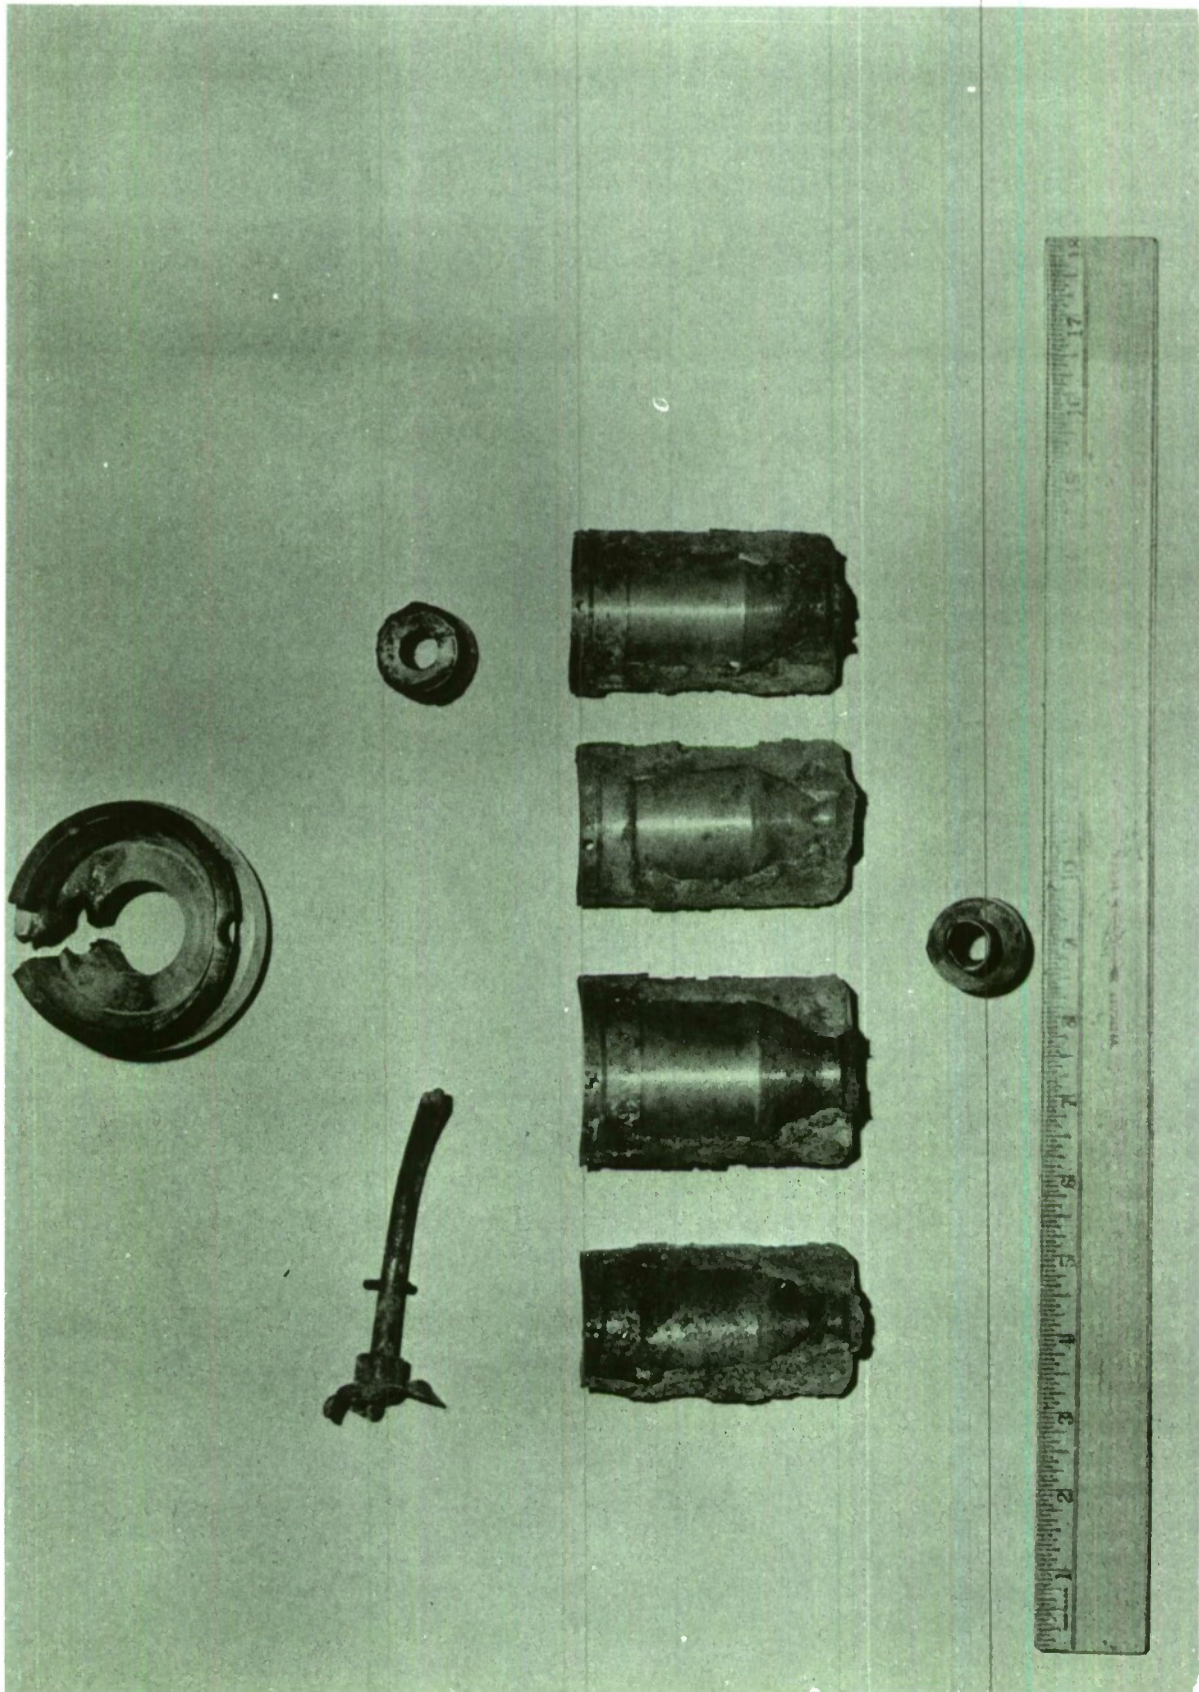
Fig. 9 Pieces of in-line mixer body recovered after the explosion.

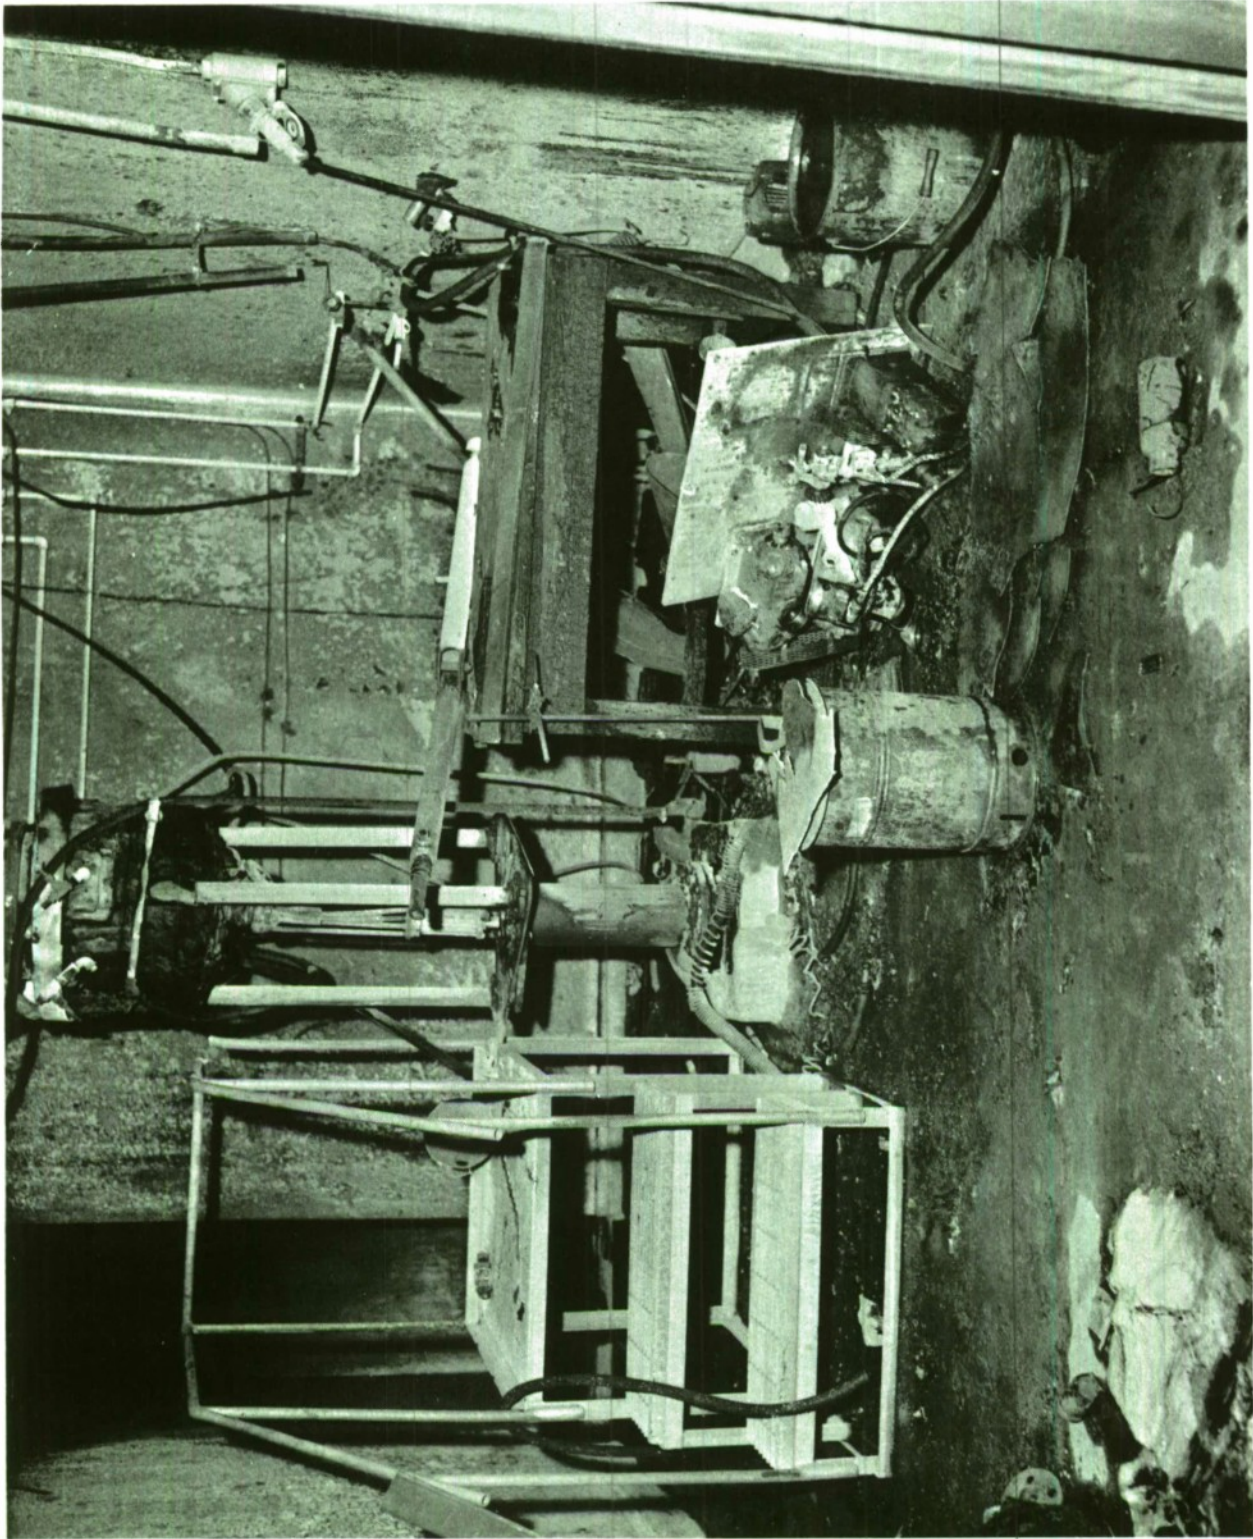
Fig. 10 General view of Bay A-8 following the explosion.

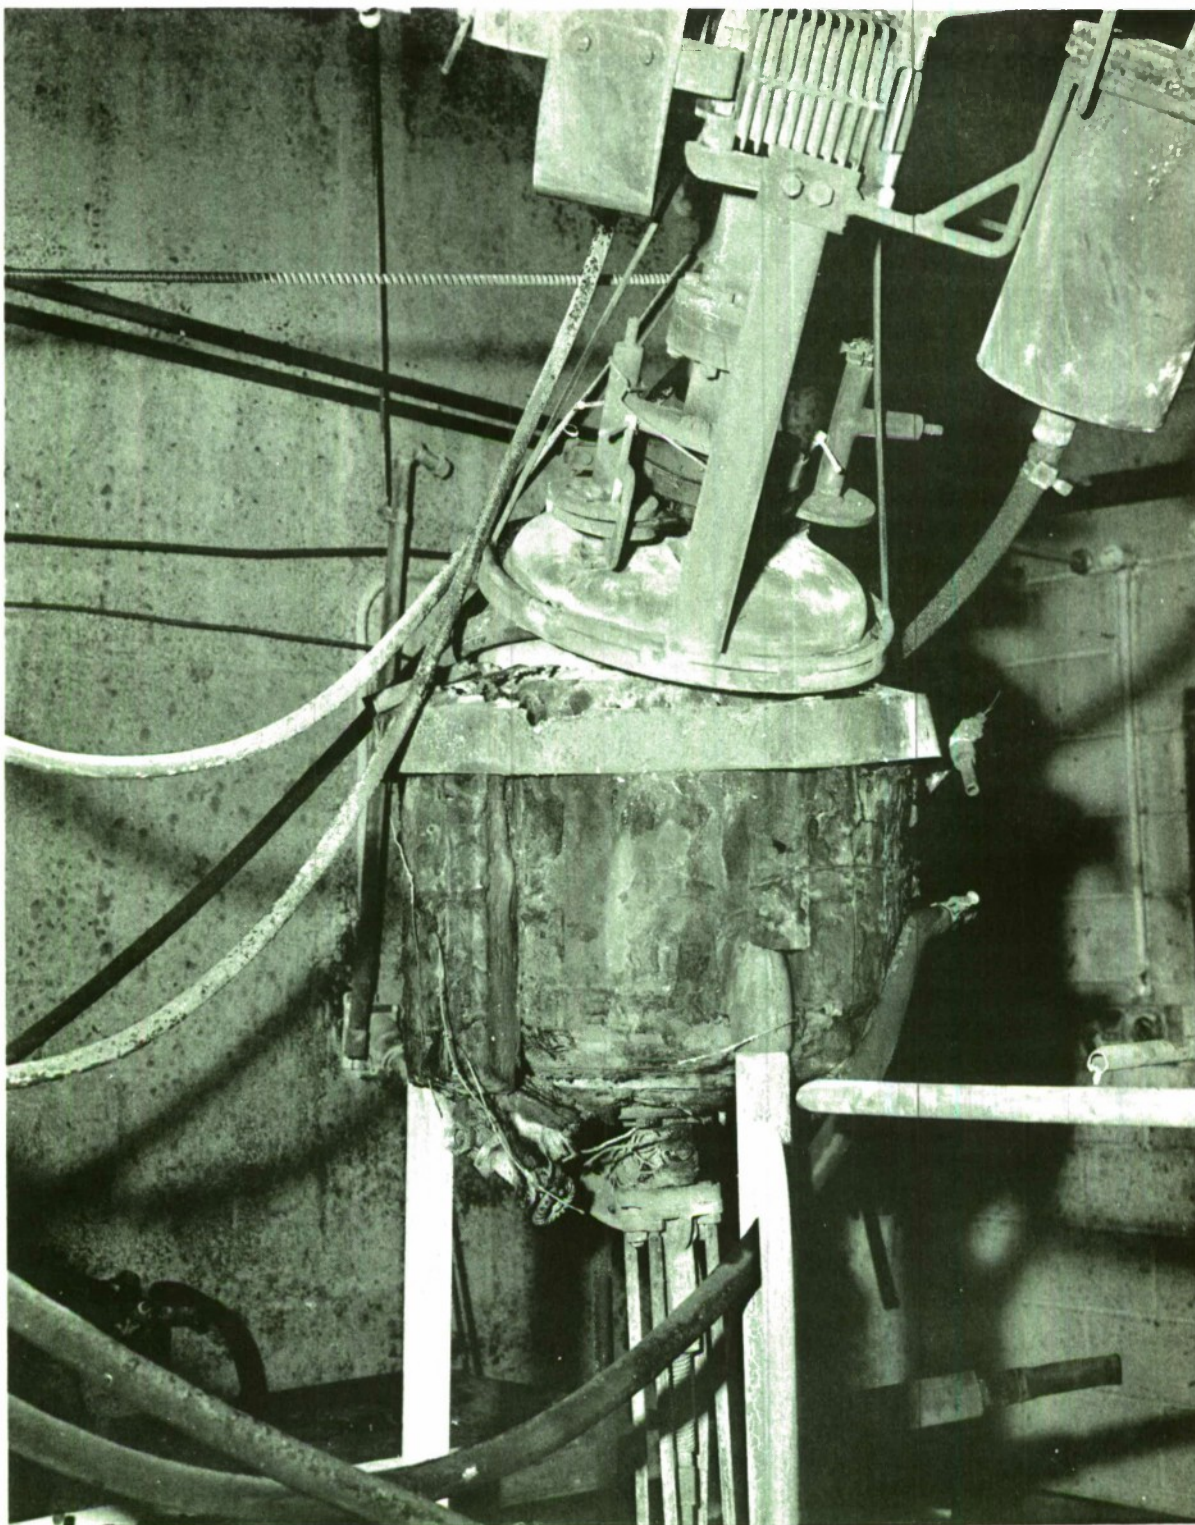
sharp boom was heard, most likely from the release of the top of the 10-gallon kettle into which the flame probably propagated from the bottom outlet. This vessel, though lidded, was vented; the pressure buildup caused the lid to break its few fastenings and rise but the lid with its agitator and drive stayed on top of the kettle (Fig. 11) while the room filled with flame and smoke from this kettle and from propellant sprayed out the top of it.

Fig. II Mixer kettle after explosion.

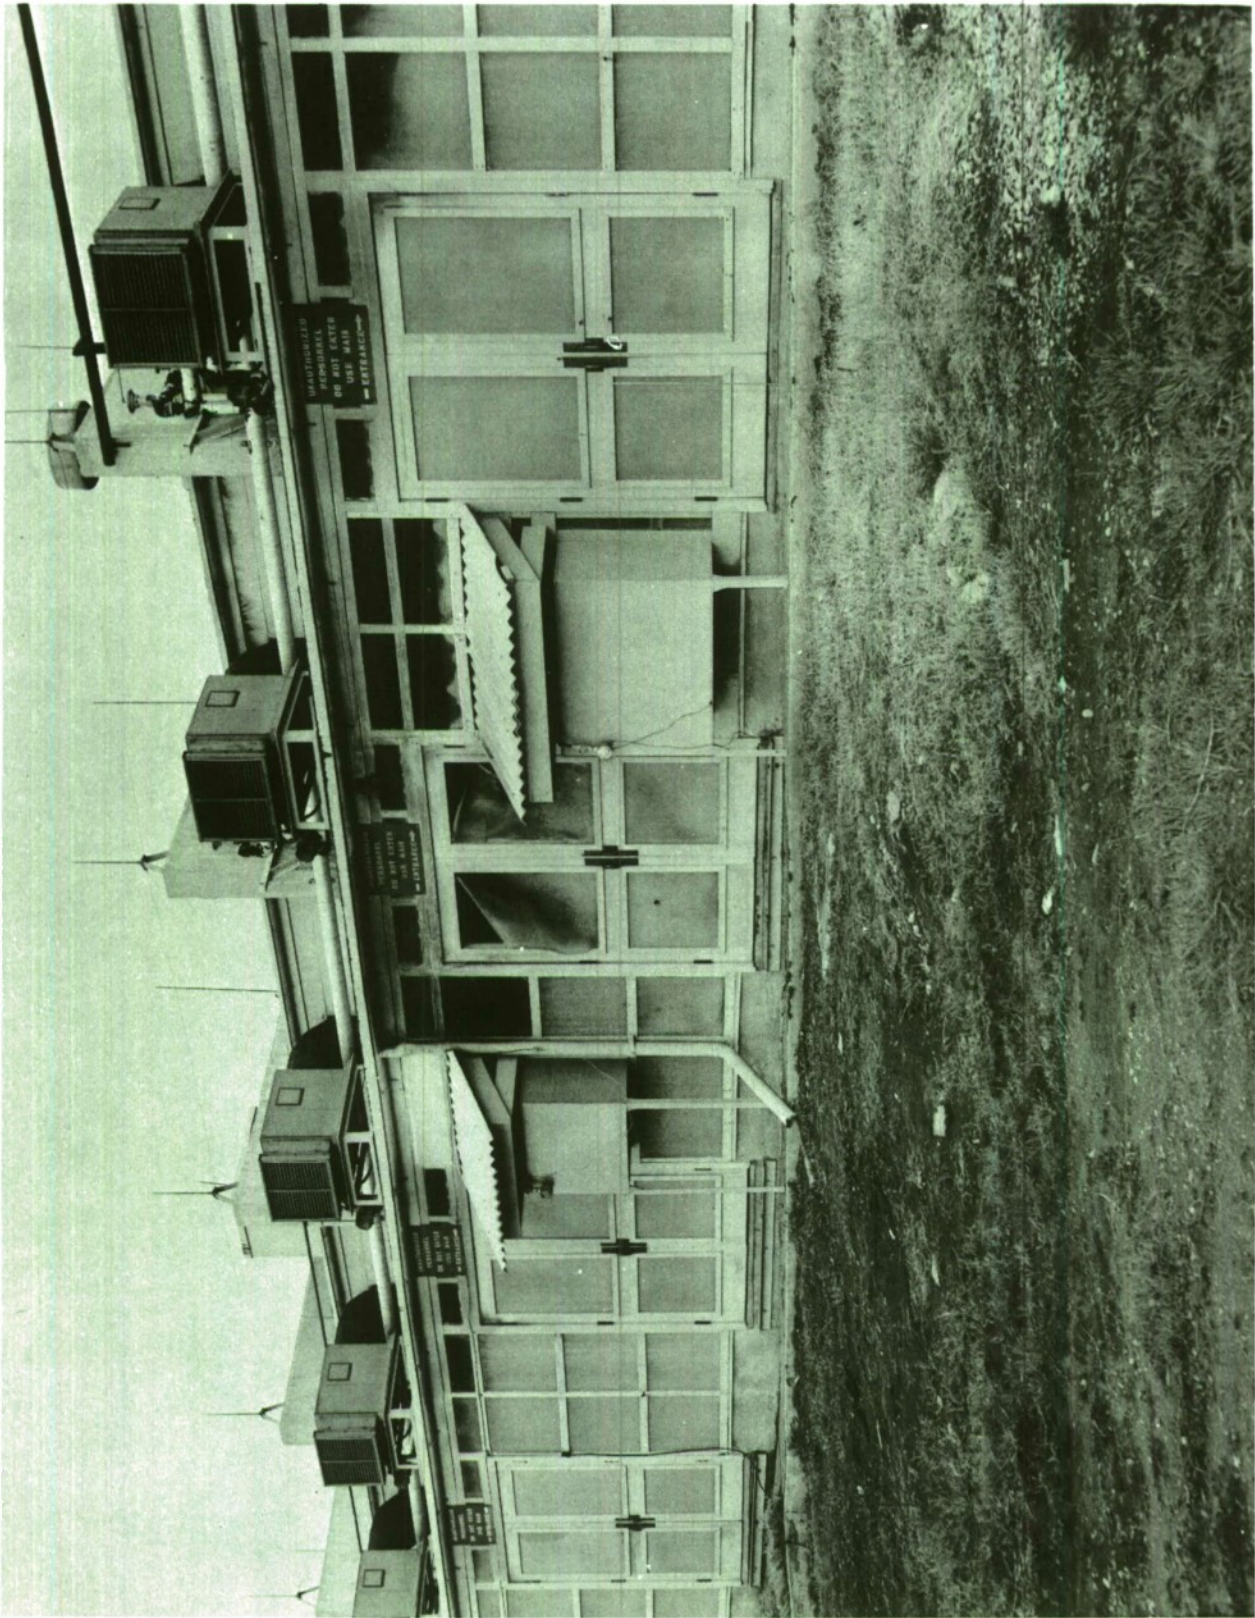
The second blow apparently pushed Corder out of the door (Fig. 12) between the corridor and the field.

Fig. 12 East side of Bldg. 7595. Door on which screens are torn is opposite Bay A-8.

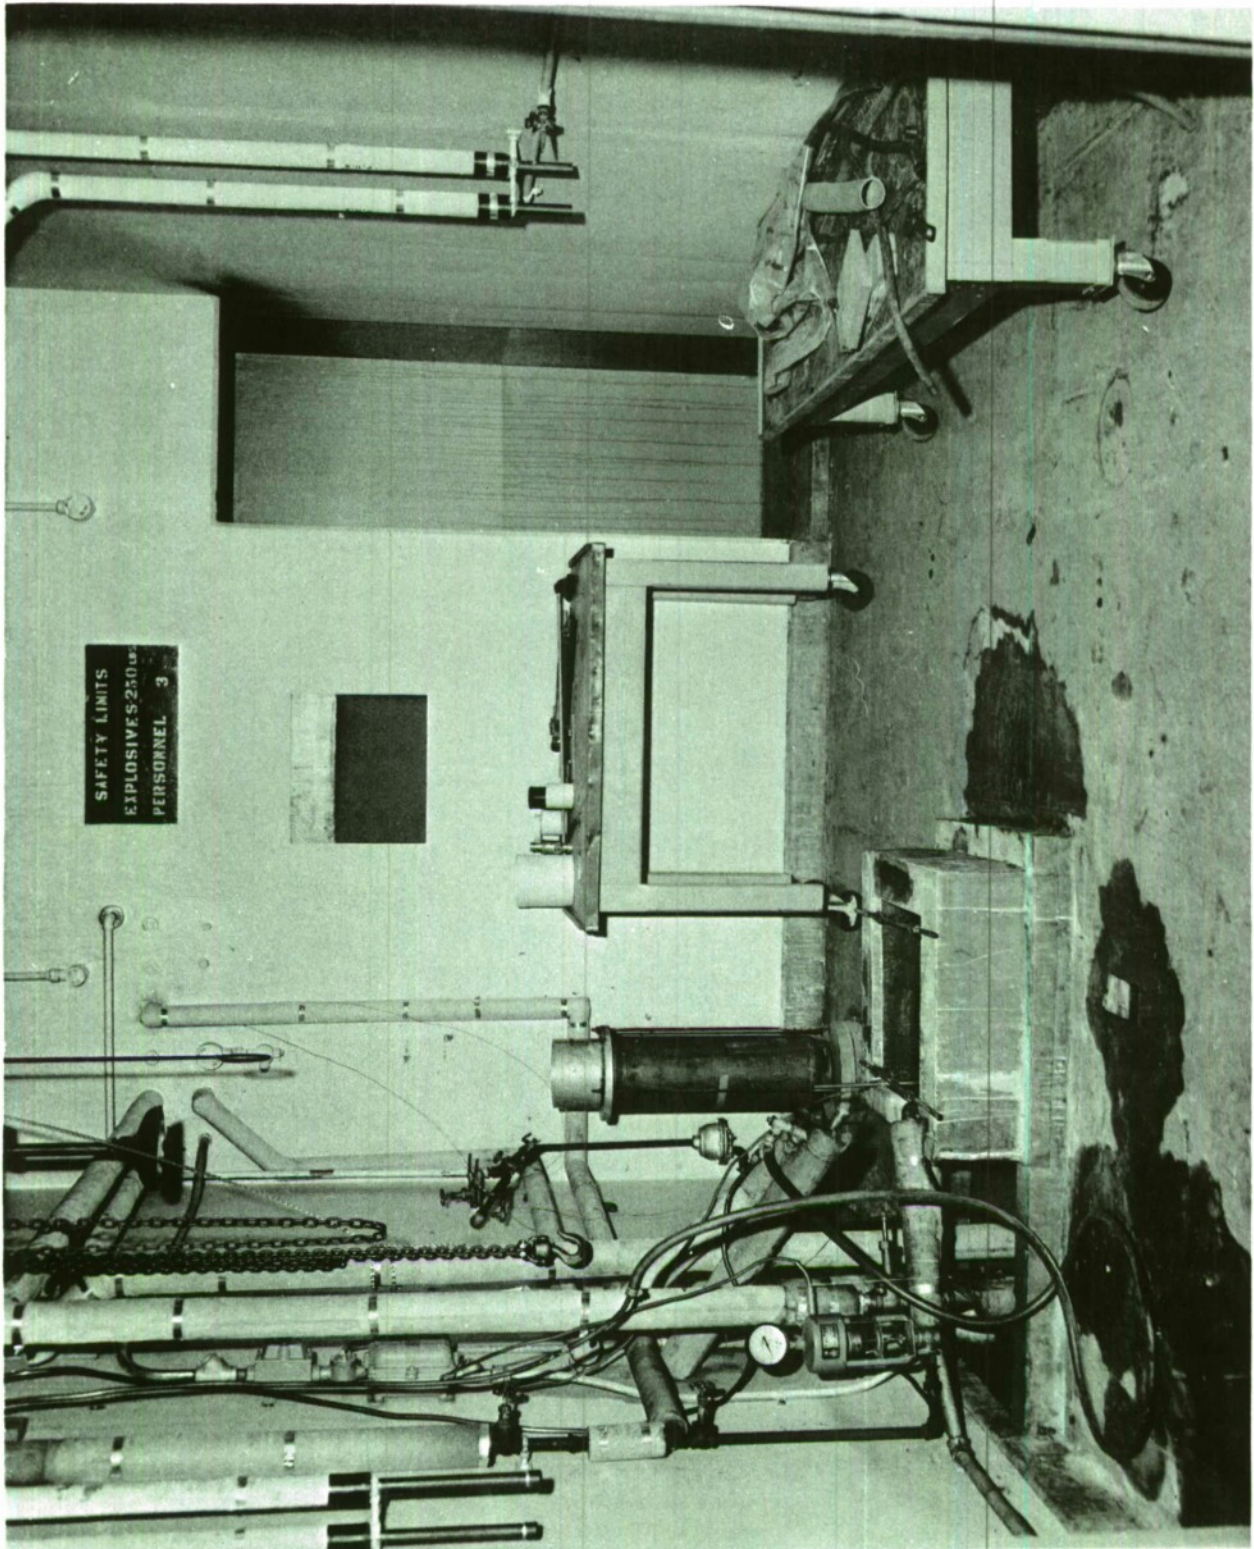
One or more lighter blows were heard later by some observers, perhaps from the vacuum trap on the kettle or other sources. The hoses on either side of the pump burned, but neither the hose through the wall nor the section in the pump ignited. The pump happened to be in a condition where the fingers had both ends of the hose in it sealed off. No part of the blast or fire propagated to the casting pit (motor) bay (Fig. 13) or to the control area in the west corridor (Fig. 14).

Fig. 13 Casting pit bay following explosion in adjacent bay.

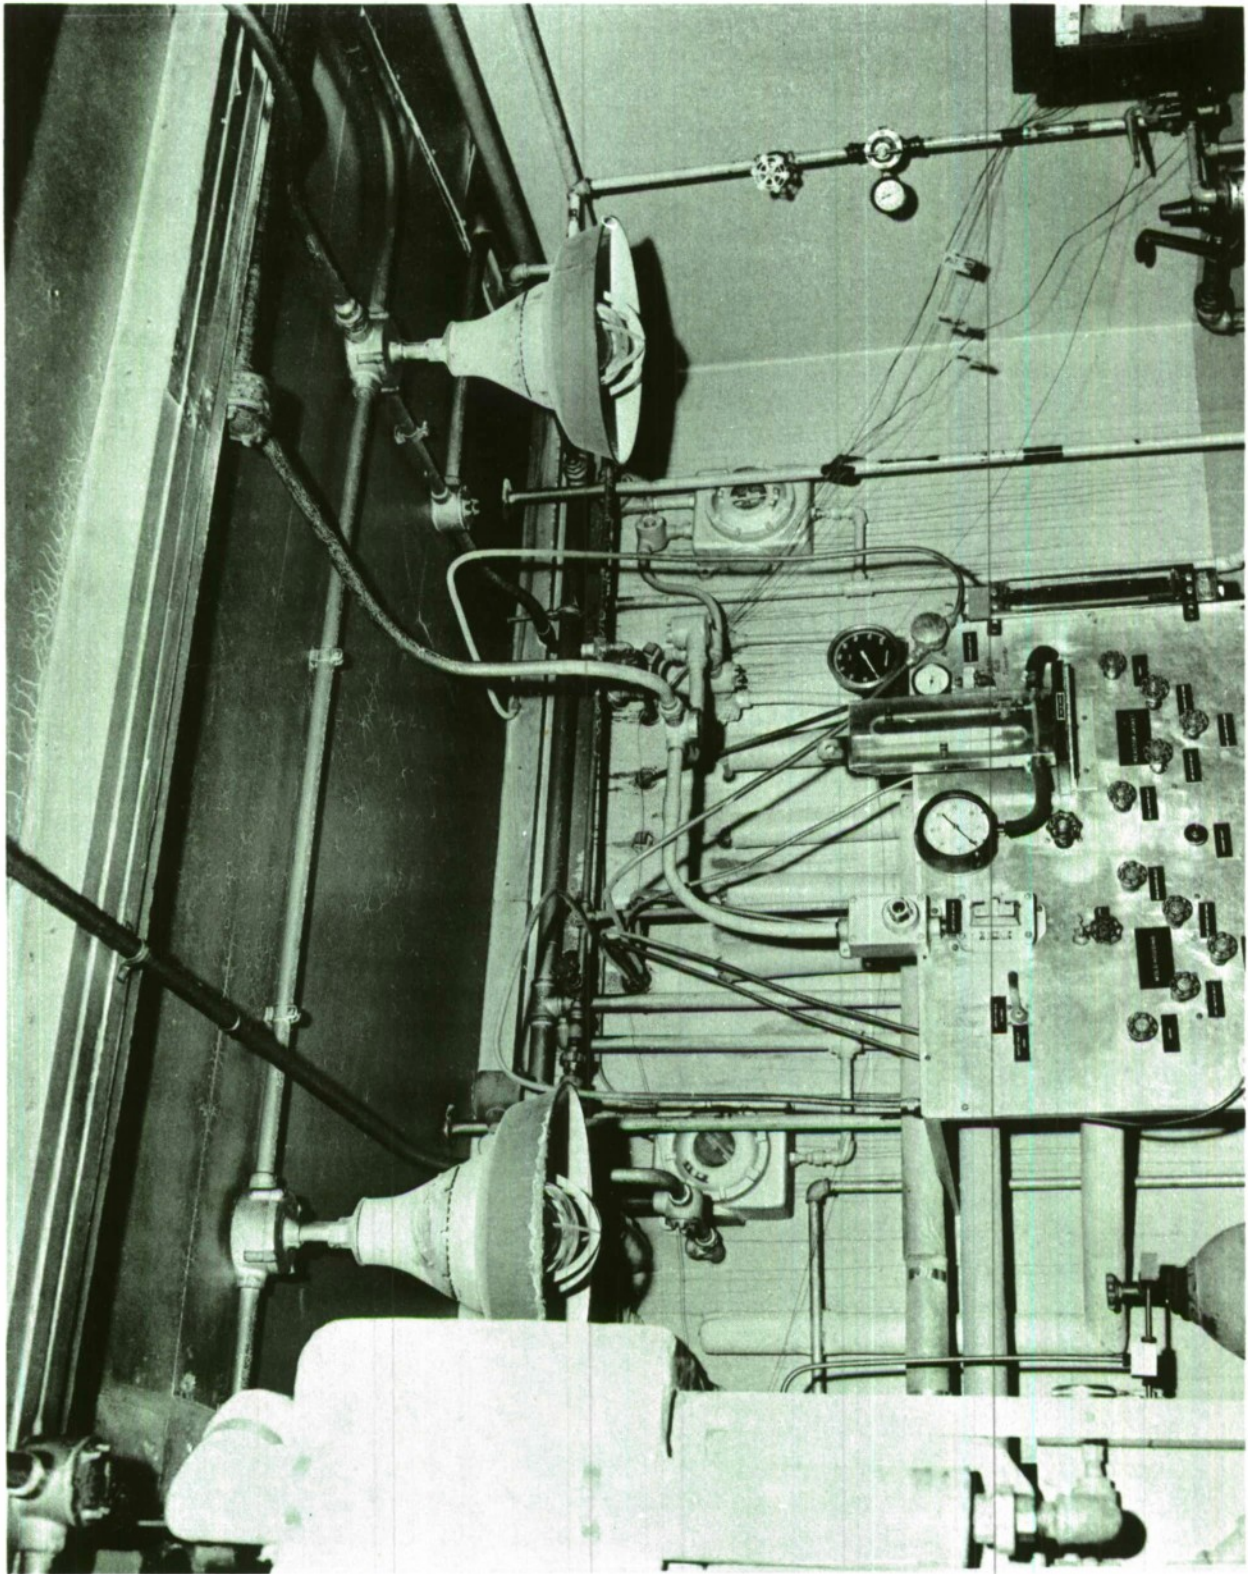
Fig. 14 Control area in west corridor following the explosion. Blackened area near ceiling was caused by smoke.

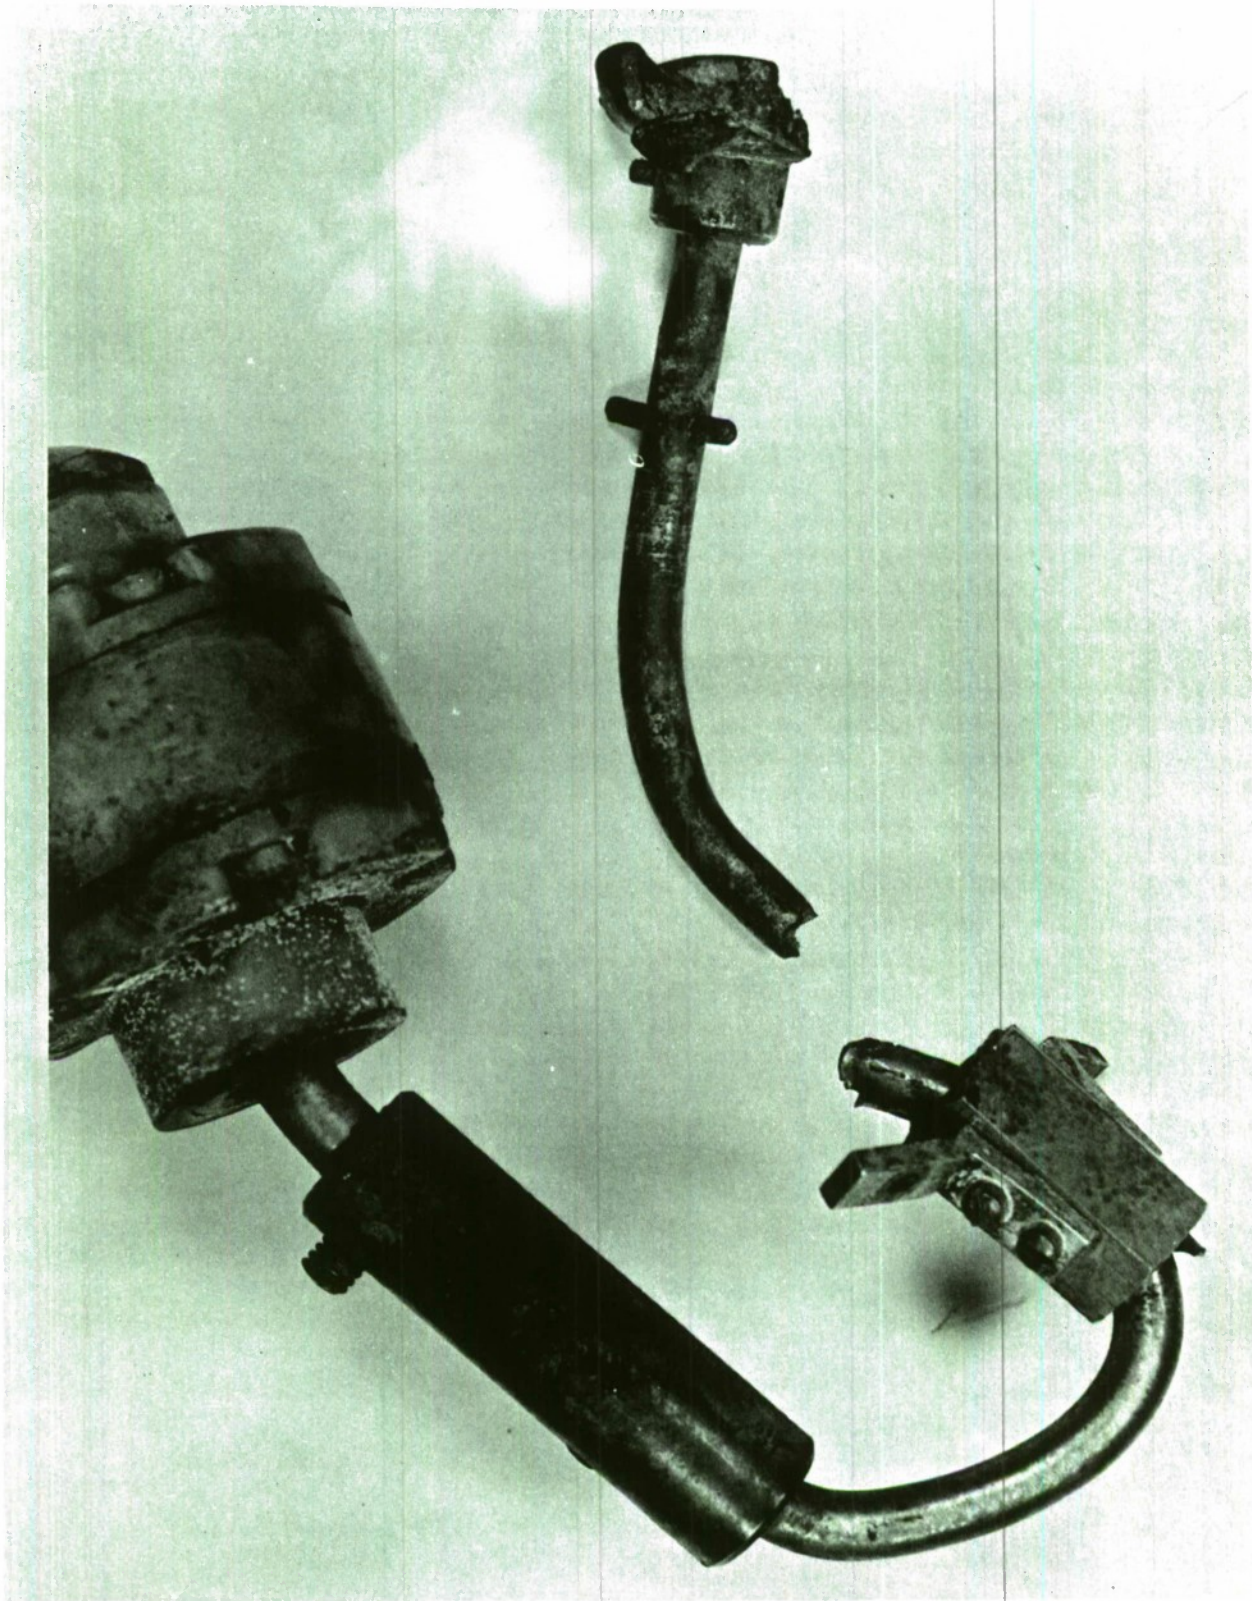
2. The explosion appears to have been caused by inadequate design of the propeller shaft packing system of the in-line mixer which permitted metal-to-metal contact or pinching of propellant between the shaft and the mixer head.

Fig. 15 In-line mixer shaft following explosion. Slight scoring can be seen above the pin near the impeller.

1. Redesign of processing equipment to eliminate all possibilities for frictional or metal-to-metal contact in the direct presence of propellant.
